SAFETY ALERT SA0008

SUBJECT: Additional Electrical Protection

MODELS AFFECTED: CC11-100 and CC11-160 S/N 0001, 00002 through 00177.

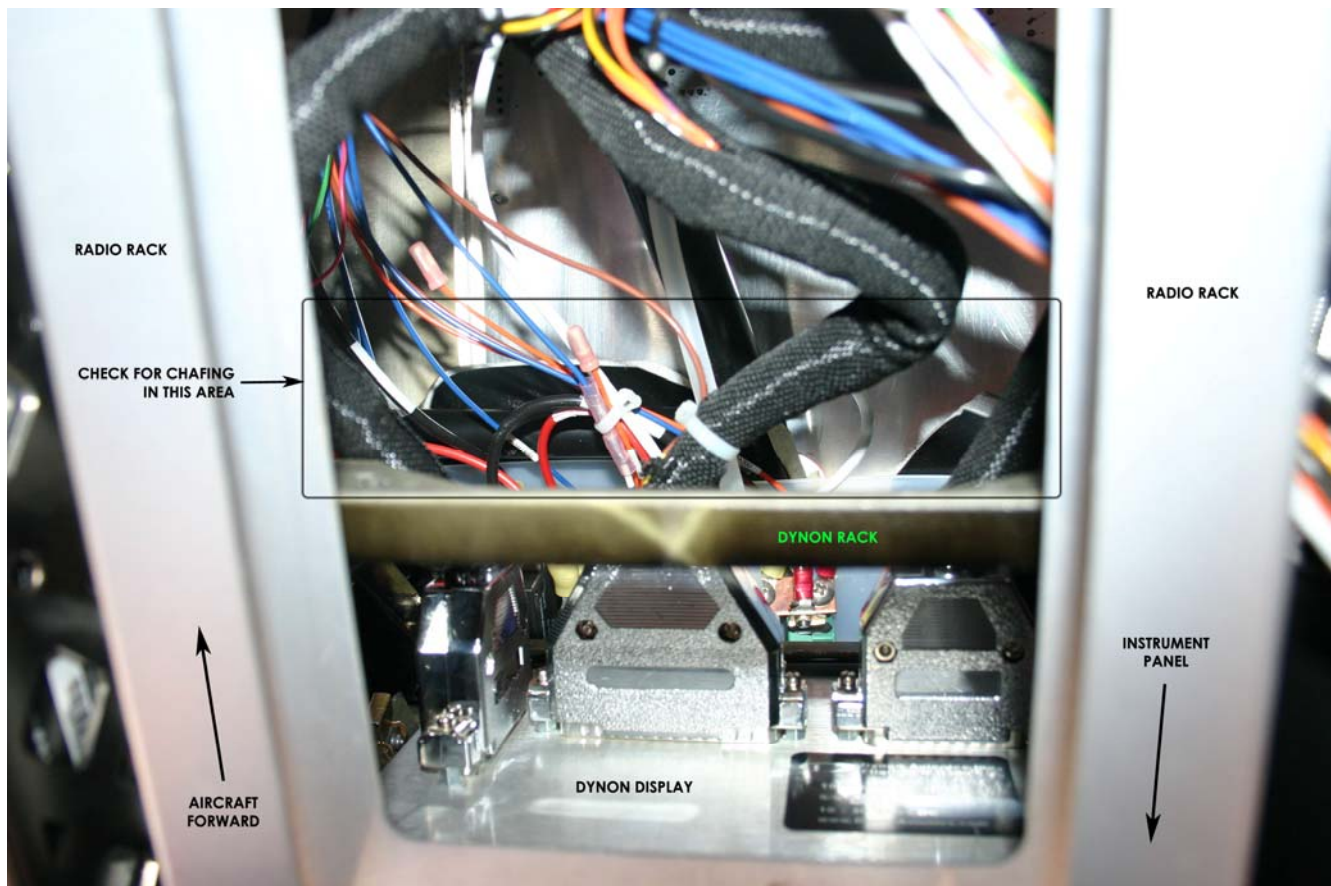
Figure 2 - View from under looking up behind instrument panel

- v. Carefully inspect all wires, especially the ones that run from the circuit breakers and switches above the Dynon. Check for chaffing from contact with avionics or aircraft structure. (See Figure 2)

- b. Repair (if required).
 - i. If any wires are chaffed, repair per AC43.13 or AC65-15A. New jumpers may be fabricated using Mil-Spec 22759/16 (Tefzel) or equivalent wire. 12GA jumpers may be replaced with 10GA; 14GA or smaller may be repaired with a butt splice.
 - ii. If any wires are sagging and could possibly come into contact with the avionics, secure them in place.
- c. Installation of chafe protection.
 - i. Clean the upper part of the Dynon
