# SENSENICH PROPELLER MANUFACTURING COMPANY, INC.

## Service Memo C08-1E Issue Date: 8-26-09

Hub clamp bolt replacement for the 2EK series Composite propeller retention system. Lowering the time between clamp bolt replacements to **10 hours**.

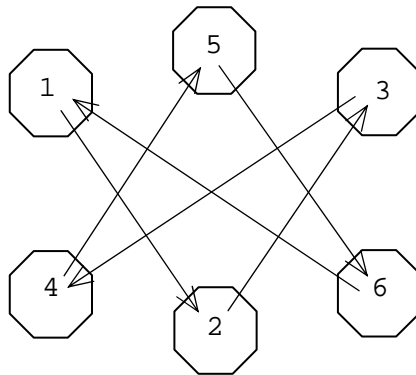
Recent incidents of hub clamp bolt failures used to secure the propeller hub halves have prompted Sensenich Propeller Mfg. Company Inc. to issue a service memo to replace and torque to 28-30 Ft-lb. the (6)-AN6-15A clamp bolts every **10 hours** of operation. Please call (717-569-0435) or email ([sales@sensenich.com](mailto:sales@sensenich.com)) the Sensenich Propeller Mfg. Company Inc. for replacement bolts at no cost.

Using a calibrated torque wrench and following the pattern shown below. Tighten the bolts in  $\frac{1}{4}$  to  $\frac{1}{2}$  turn increments (this will take several passes) until the proper torque given in **Table 1** is reached. It is important to maintain an even gap between the hub halves.
