SAFETY ALERT SA0008

SUBJECT: Additional Electrical Protection

MODELS AFFECTED: CC11-100 and CC11-160 S/N 0001, 00002 through 00177.

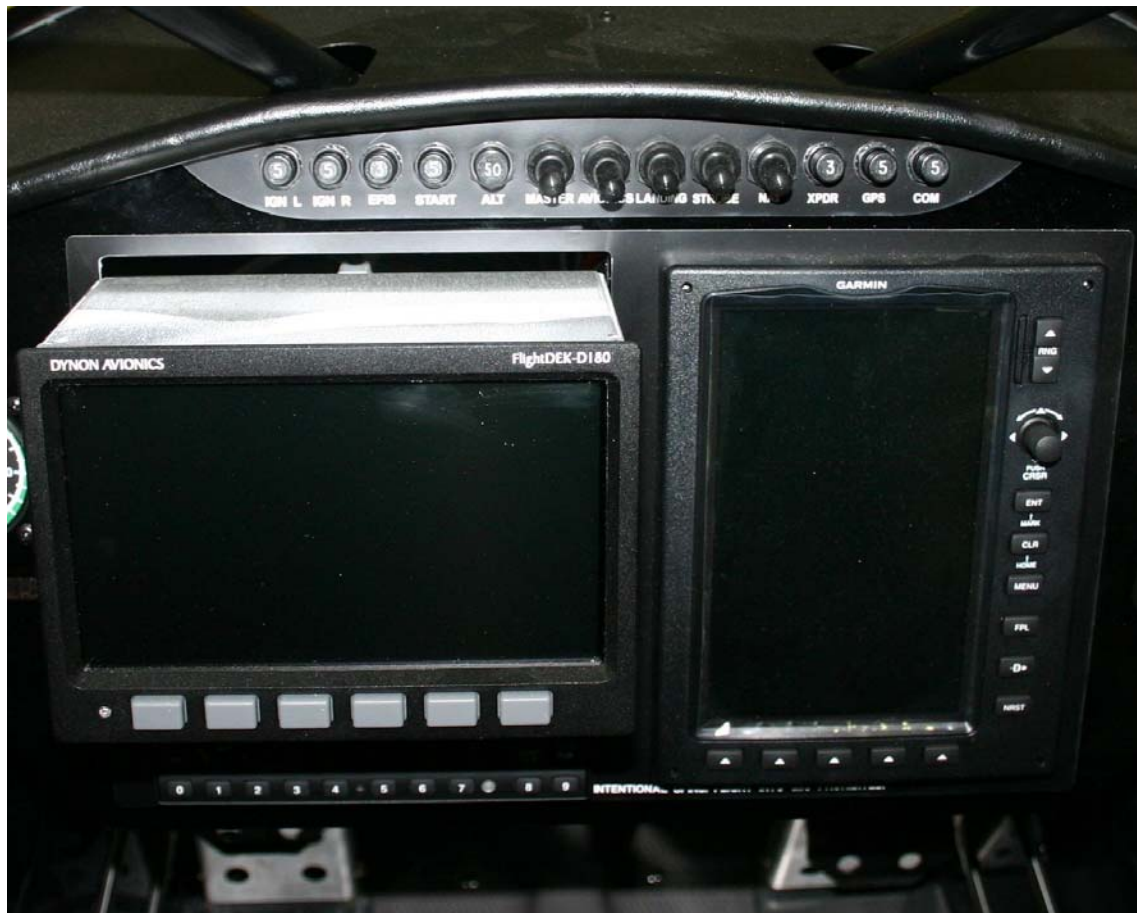
Figure 1 - View of instrument panel with Dynon pulled out

PURPOSE: It has been determined that electrical wiring behind the instrument panel may chafe against adjacent equipment. This Safety Alert addresses this by adding protective chafe tape to the affected areas and inserting fusible links in certain electrical circuits.

- a. Inspection of wiring behind instrument panel.
 - i. Unscrew Dynon from its mounting tray.
 - ii. Pull out the Dynon while taking care as the screw that secures the Dynon to its tray protrudes and could cause an injury or scratch the adjacent equipment or structure.
 - iii. Remove the COM radio and transponder.
 - iv. If equipped with the Garmin GDU370 or GDU375, remove it, too.

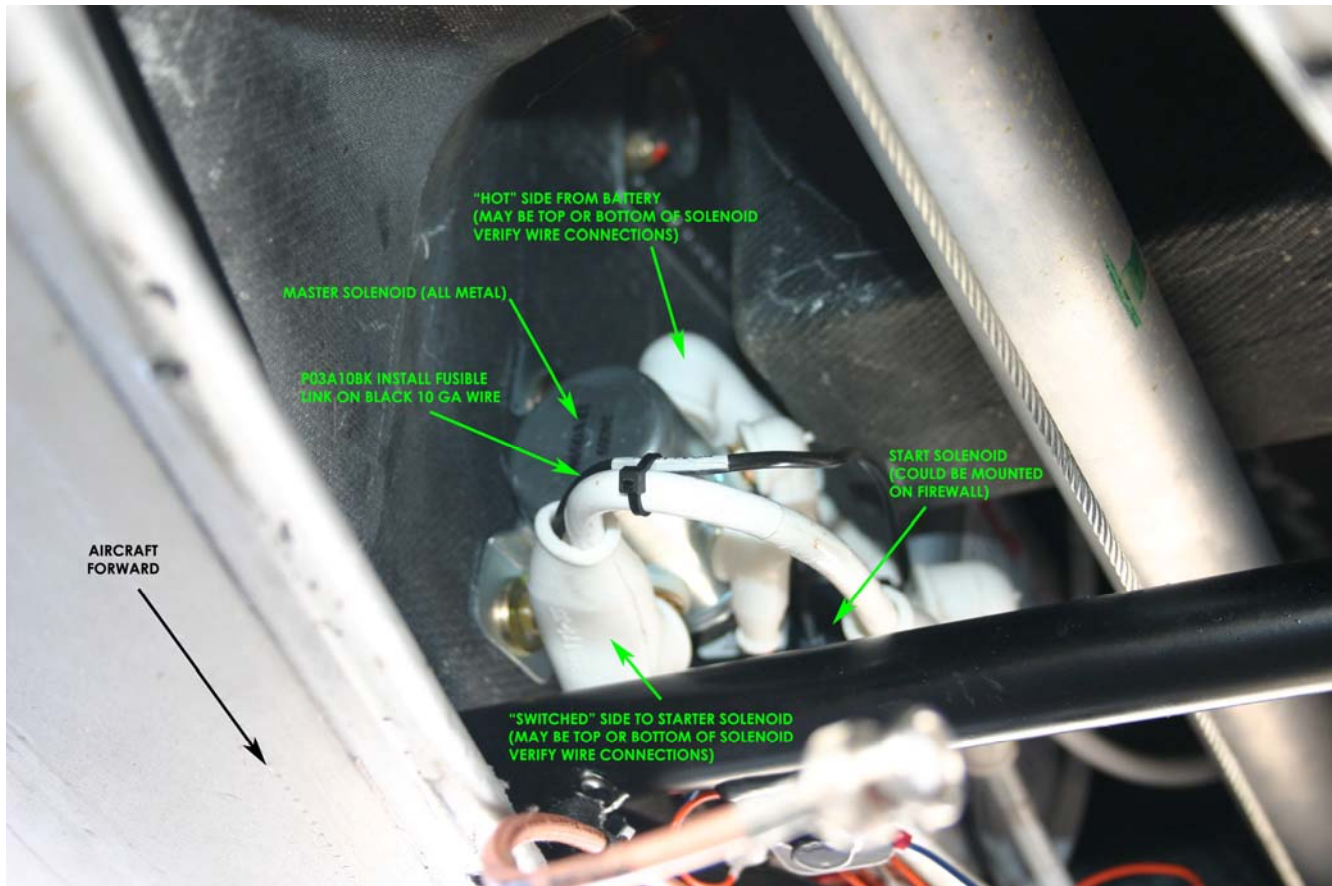
Figure 5 - View looking up through access

- b. Identify the black 10 GA wire attached to the Master Solenoid labeled: P03A10BK. (See Figure 5)

- i. Remove the ring terminal from the solenoid. Pull out the P03A10BK wire for proper fit and routing of a fusible link.
- ii. Clip off the existing ring terminal on P03A10BK
