SUBJECT: Aileron Cable Pulley Diameter Inspection

MODELS AFFECTED: CC18-180A SERIAL NUMBER 0001
 CC18-180 SERIAL NUMBERS 0002 THROUGH 0038

CubCrafters, Inc		1918 South 16 th Ave, Yakima WA 98903	
Document Title		Document No	Page
Service Bulletin SB0012 Aileron Pulley Diameter Inspection		SB0012	2 of 2

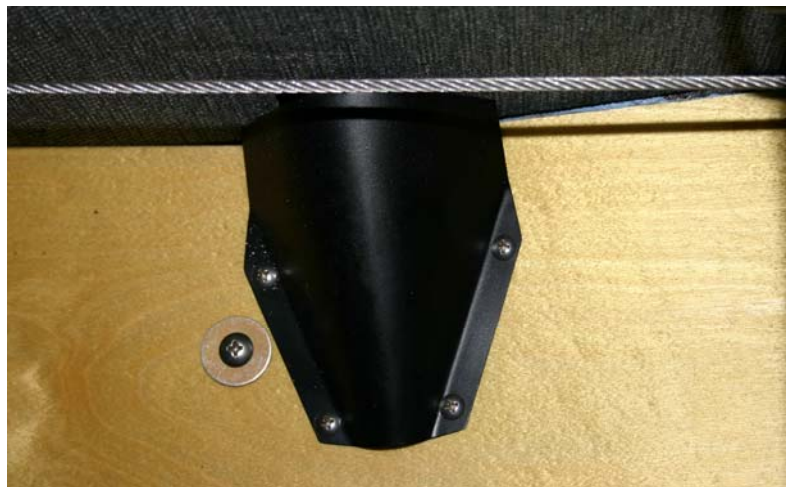
FIGURE 1 – Right Side Aileron Pulley Cover-Installed

1. Locate the lower aileron cable pulley covers located on the cabin interior, approximately mid-cabin, both left and right sides. Remove the screws and the cover.

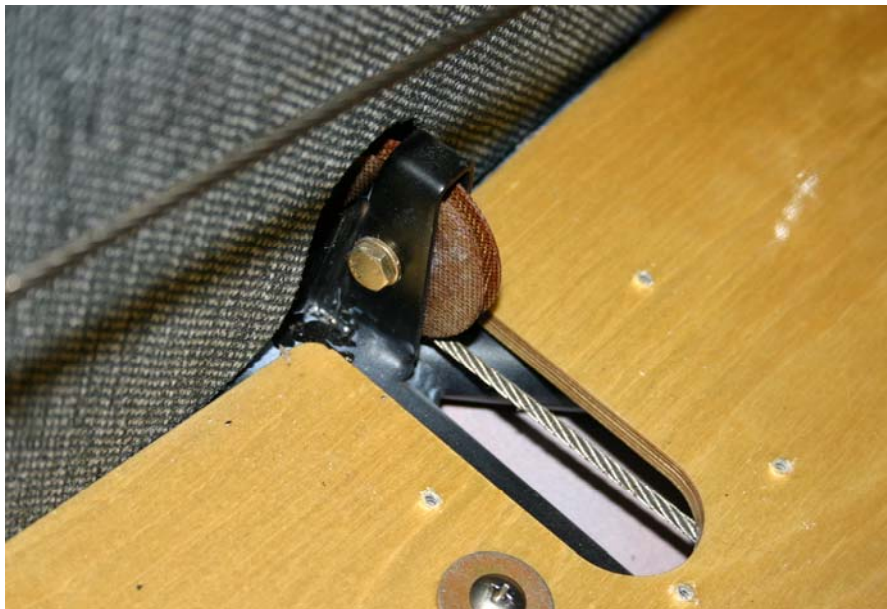
2. The correct pulley diameter is 1.75". The cable guard should be close enough to the cable that it would be impossible for the cable to come out of the "V" groove in the pulley. If an incorrect 1.5" pulley is installed, please contact Cub Crafters with a request for the correct diameter pulley.

FIGURE 2 – Cover Removed-Inspection of Pulley Diameter

3. If the correct pulley (1.75" diameter) is installed, there is no further action required. Make appropriate logbook entries stating SB0012 has been complied with.
